Solstice & Sky Body Adjustments

SKY

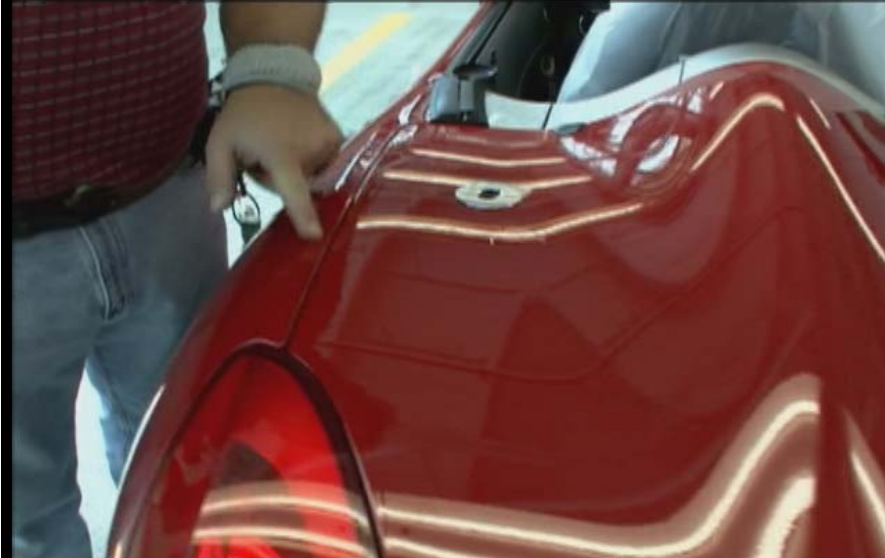
Condition: *The deck lid gap is not equal from side to side to fender*
(gap 1.5 – 3.0 mm)

Raise or lower the wedge bumper. If you raise one side to increase the gap, you need to lower the opposite side to close the gap

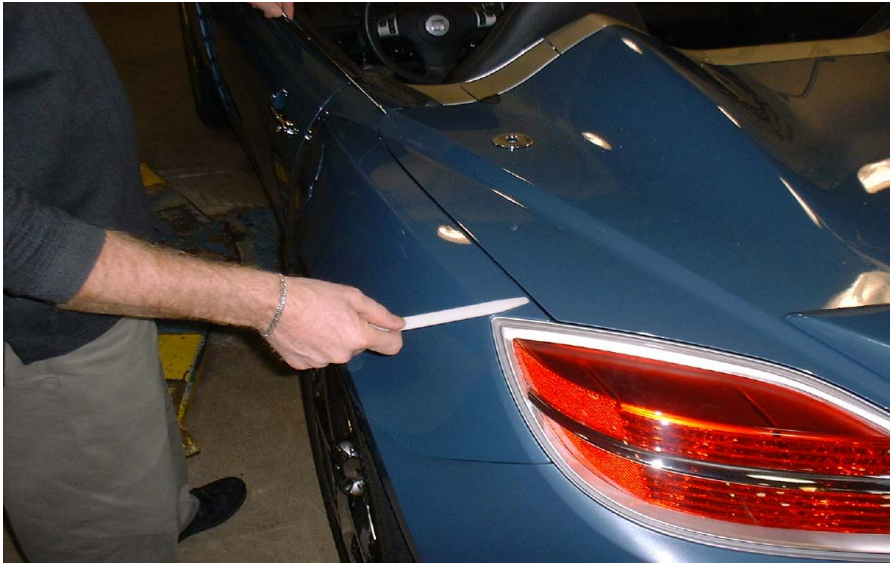
Condition: The deck lid is too low or high in the opening as measured at the quarter panel (gap -2.0 to + 2.0 mm) and the deck lid is not flush at the tail lamp area

First you need to check is the flushness of the deck to quarter at the tail lamp area. This must be flush before any adjustments are made.

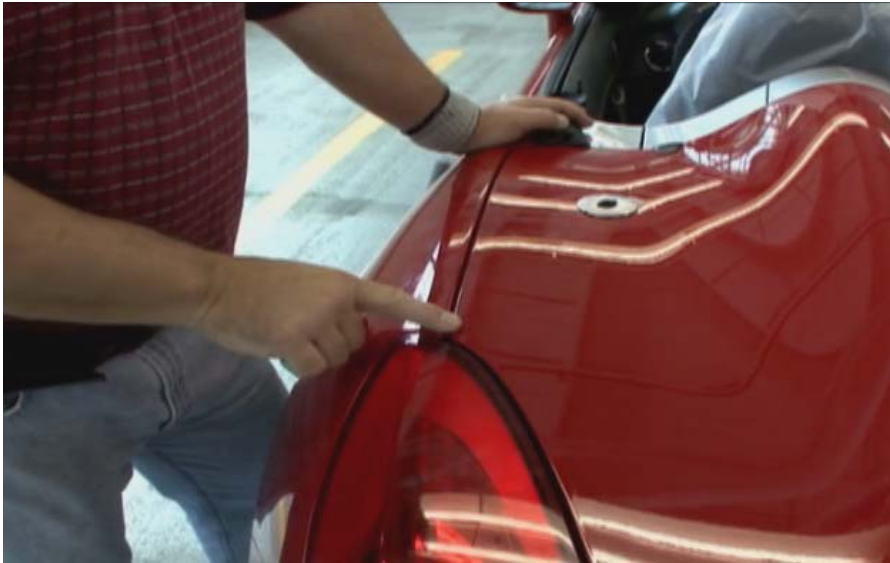
Condition: One side of the deck lid is too low or high in the opening as measured at the quarter panel, the deck lid is flush at the tail lamp area and the other side is sub-flush to the quarter panel (gap -2.0 to + 2.0 mm).

The deck flush fit on one side is good, the flush gap at both tail lamps is good but the deck is high/low at the front (with buttress in place)

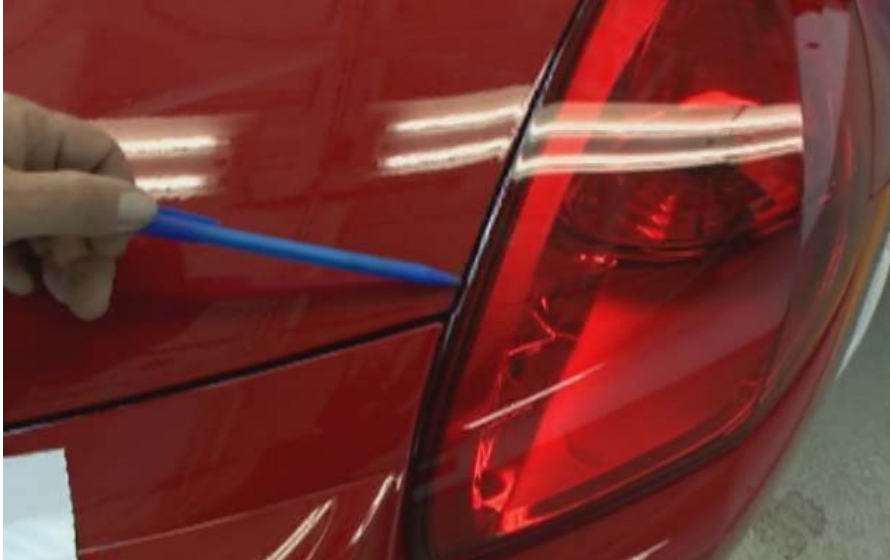
Condition: Tail lamp to deck lid not flush (gap 1.0 mm) or the gap between the deck and lamp is tight or excessive.

In this picture the gap between the tail lamp and deck lid is too tight. The tail lamp is also too low (sub-flush) to the deck lid.

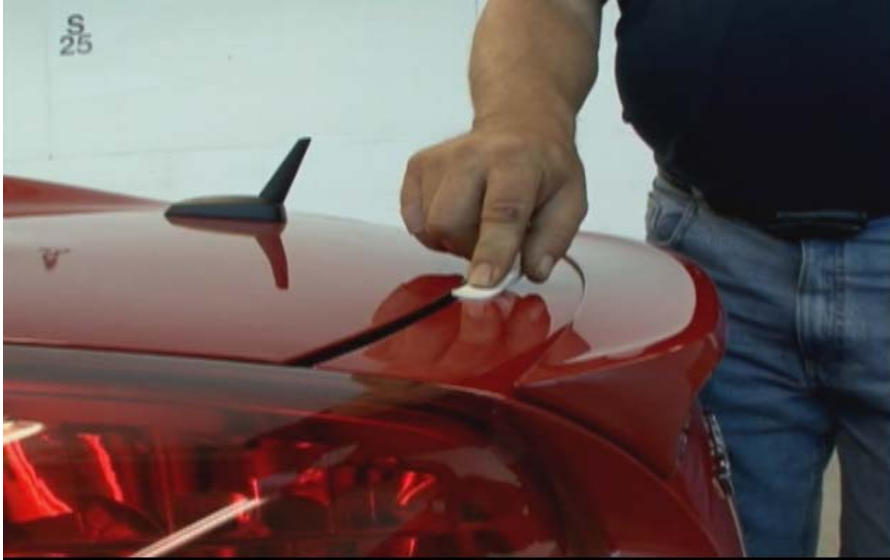
Condition: Rear Fascia flushness is high or low to the deck lid

This fascia is 2 mm too low to the deck lid. We will raise the fascia to the deck lid height.

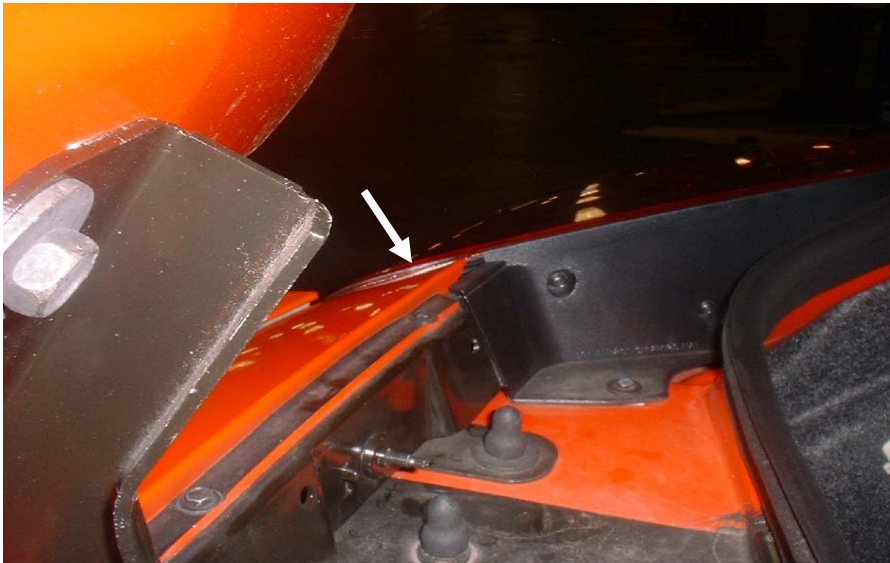
Condition: Pontiac Rear Fascia to tail lamp fit – Slight dip in fascia at tail lamp

Loosen the fascia studs then using a trim stick, pry up on the fascia mounting bracket while tightening the studs

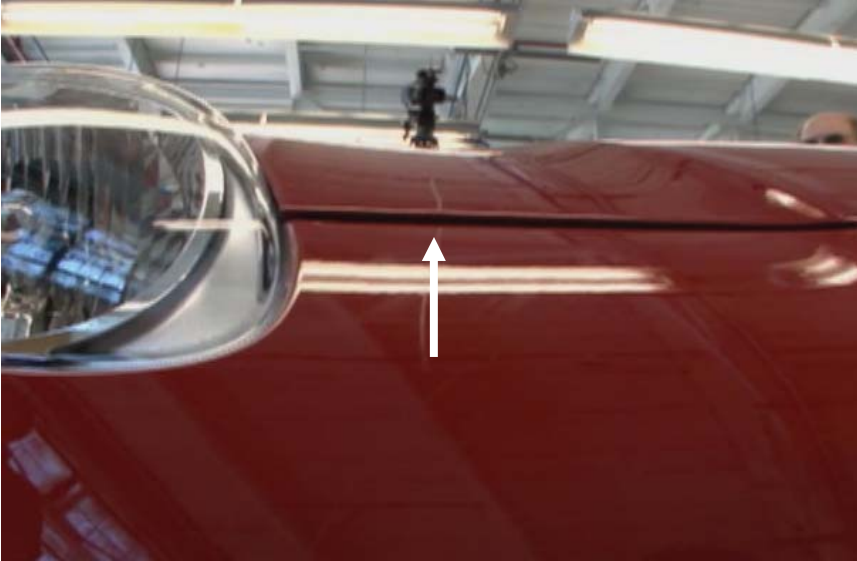
Condition: The hood to fascia gap is good side to side but low or high between the head lamps

Hood to top of door and fenders are OK but the fascia is low

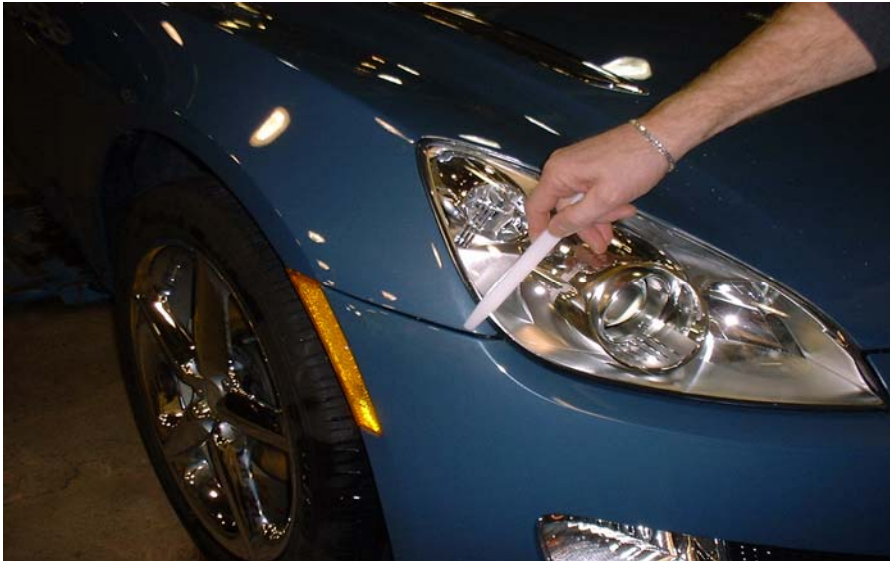
Condition: *The fascia is sticking out at the hood in the head lamp area*

If the front fascia is sticking out farther than the hood at the head lamp area, in front of the tire, and the rest of the hood to door to fender fit's are OK.

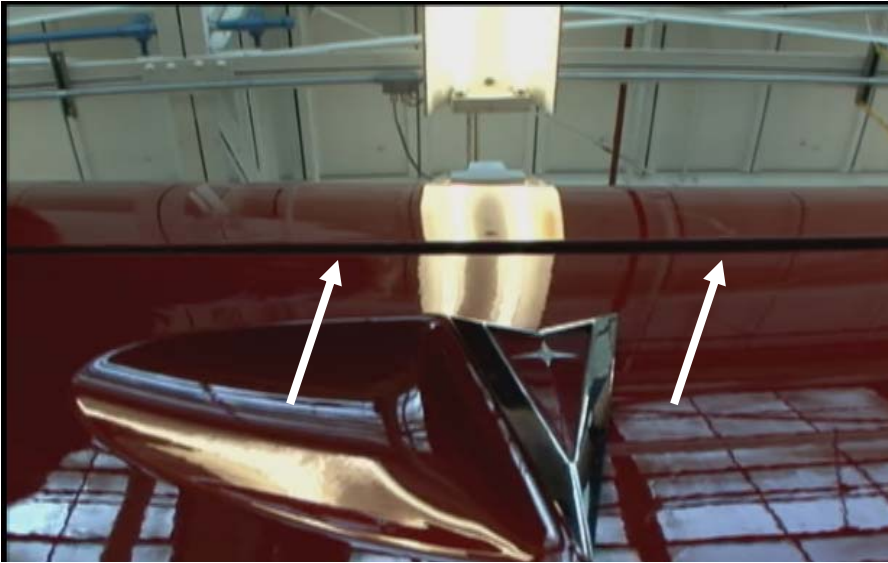
Condition: *The front fender is not flush at the hood*

This adjustment is only possible with the Pontiac because the fender is metal.

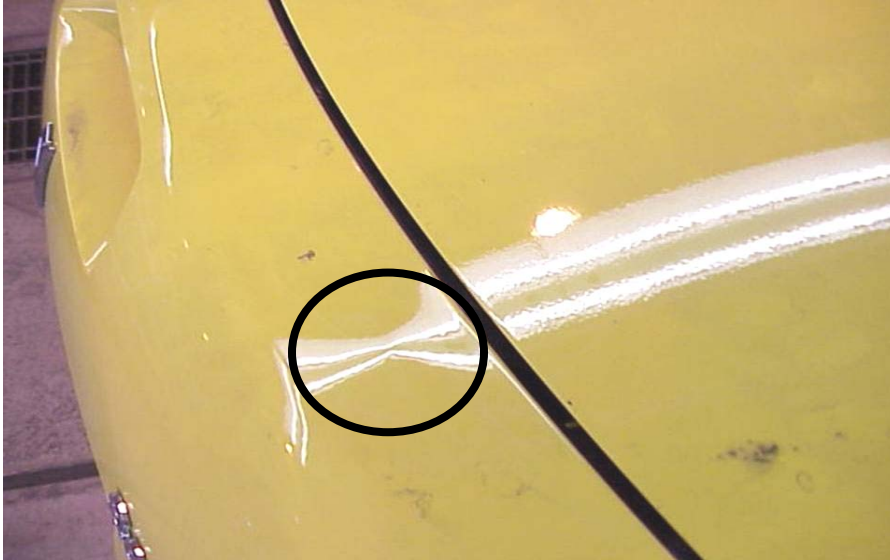
Condition: *The rear fascia has up-dings from the inside out*

This condition is caused by the over extending the deck lid when opening

Replace both hinges. The fascia will relax after the pressure from the hinge is gone.

This is not a warranty repair
