Solstice & Sky Body Adjustments

SKY

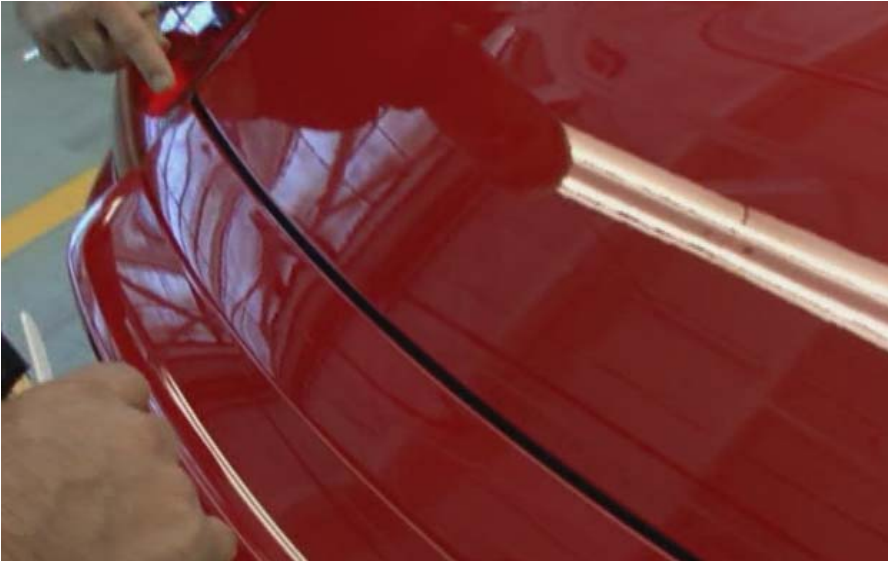
Moving this fascia up increased the gap to the deck lid.

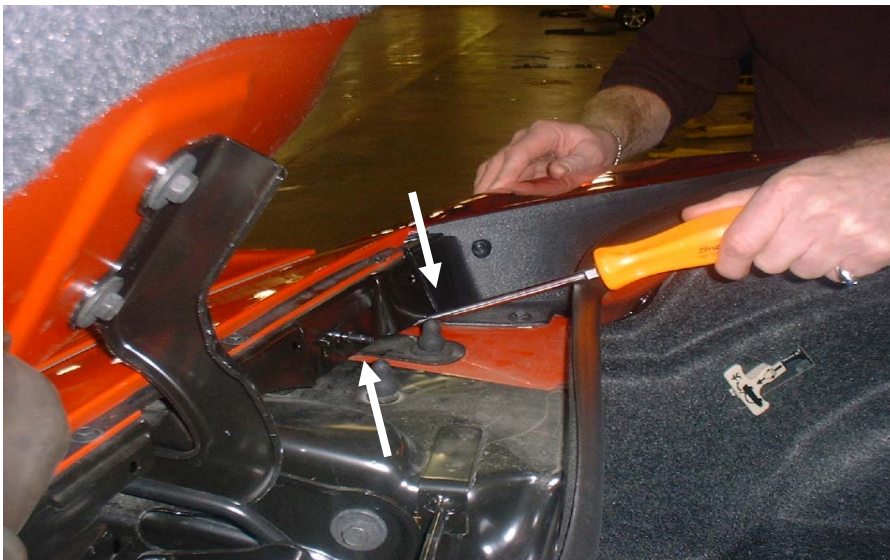
Condition: Pontiac Rear Fascia to tail lamp fit – Slight dip in fascia at tail lamp

Loosen the fascia studs then using a trim stick or covered screw driver, pry up on the fascia mounting bracket while tightening the studs

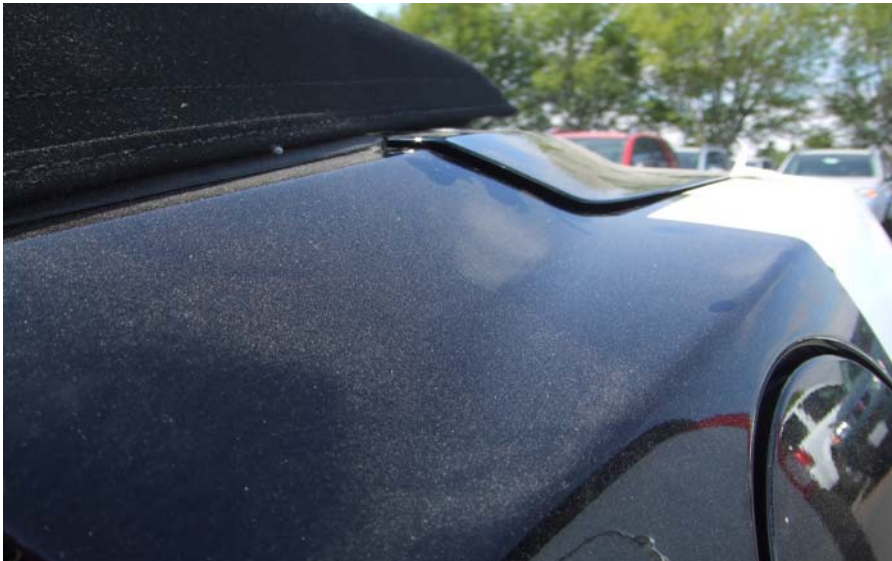
Condition: Saturn or Pontiac front of deck lid to quarter not flush (buttress latched)

The deck lid should be set sub flush (-2.0 to +2.0 mm) with the buttress latched.

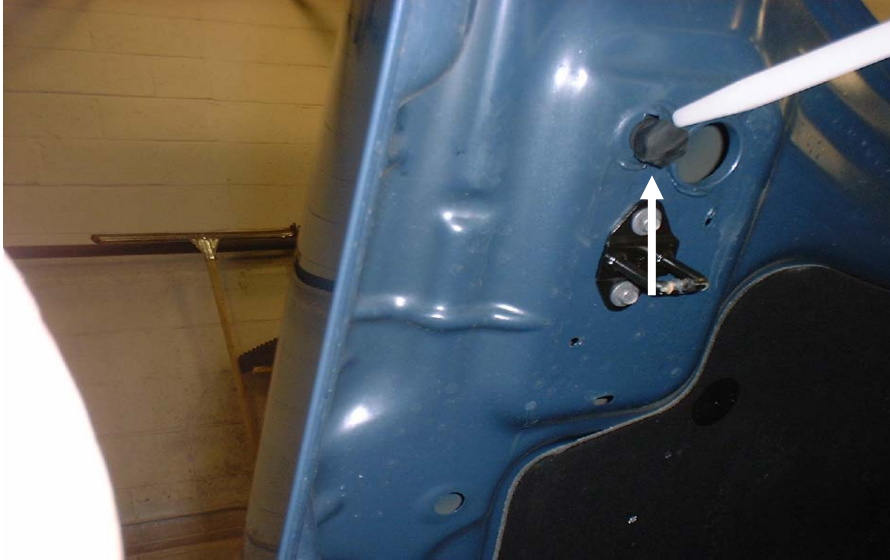
Condition: The hood sits higher or lower than the top of the door

The first adjustment is the hood bumper. Move it in or out depending on the fit

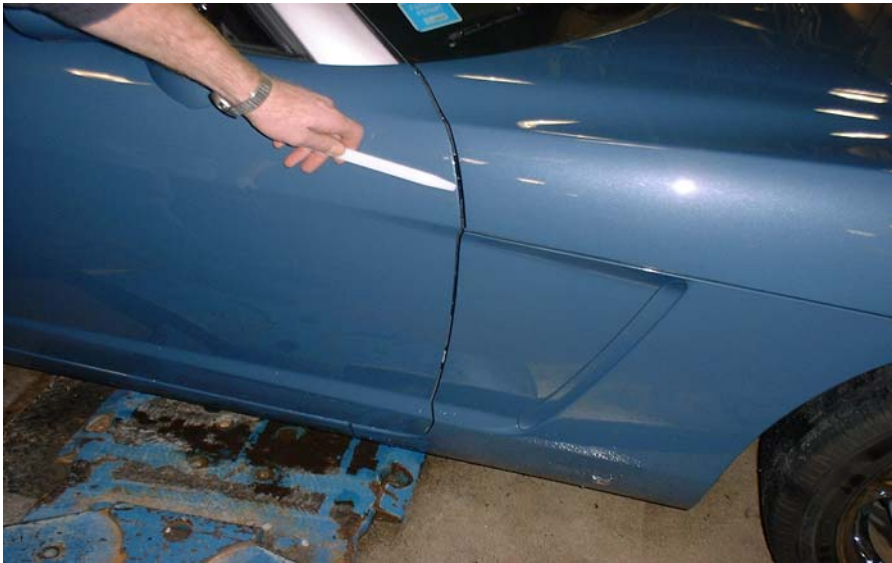
Condition: The hood to door gap is excessive or tight as measured at the middle of the door (gap parallel < 2.0 mm and min of 3.5 mm)

This gap is adjusted by the hood bumper or the front hood stop. Measure the gap half way between the top of the door and the top of the fender.

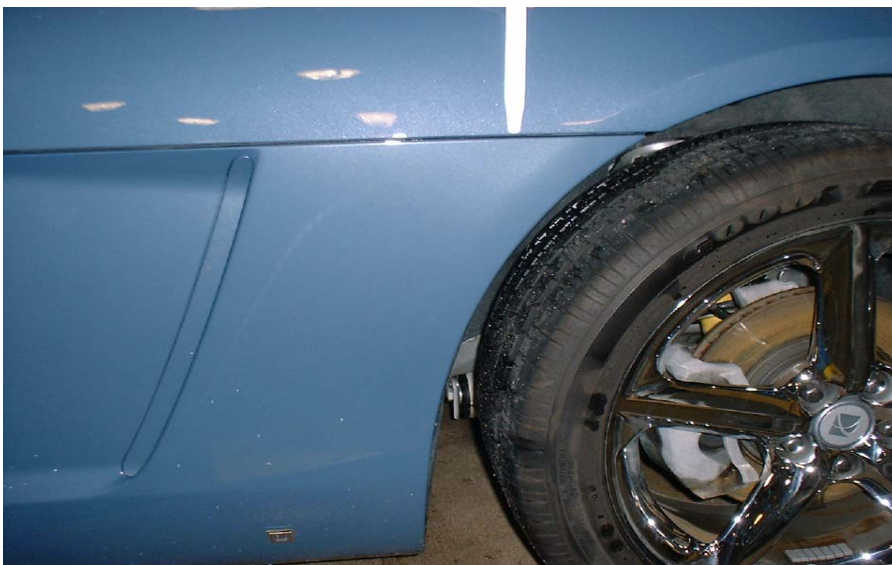
Condition: The hood to fender gap is excessive or tight

Loosen the attaching screws and the two 13 mm bolts at the lower part of the fender to make any adjustments

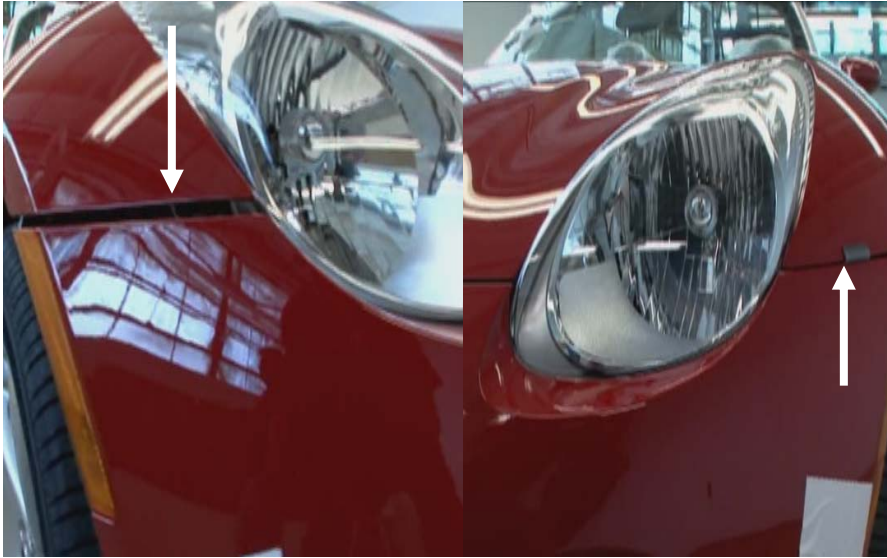
Condition: The hood to fascia gap is not equal from side to side (never less than 3 mm)

Adjust the hood stop up or down as needed. Remember, this adjustment will affect the hood to top of door to fender gaps.
